**ASTM E 90 SOUND TRANSMISSION LOSS  
TEST REPORT**

**WINDLOCH LLC**

**SERIES/MODEL: WS 75**

Report No: C4711.01-113-11  
Revision 1: 05/13/13  
Test Dates: 01/14/13  
And: 01/15/13  
Report Date: 01/24/13  
Record Retention End Date: 01/24/17

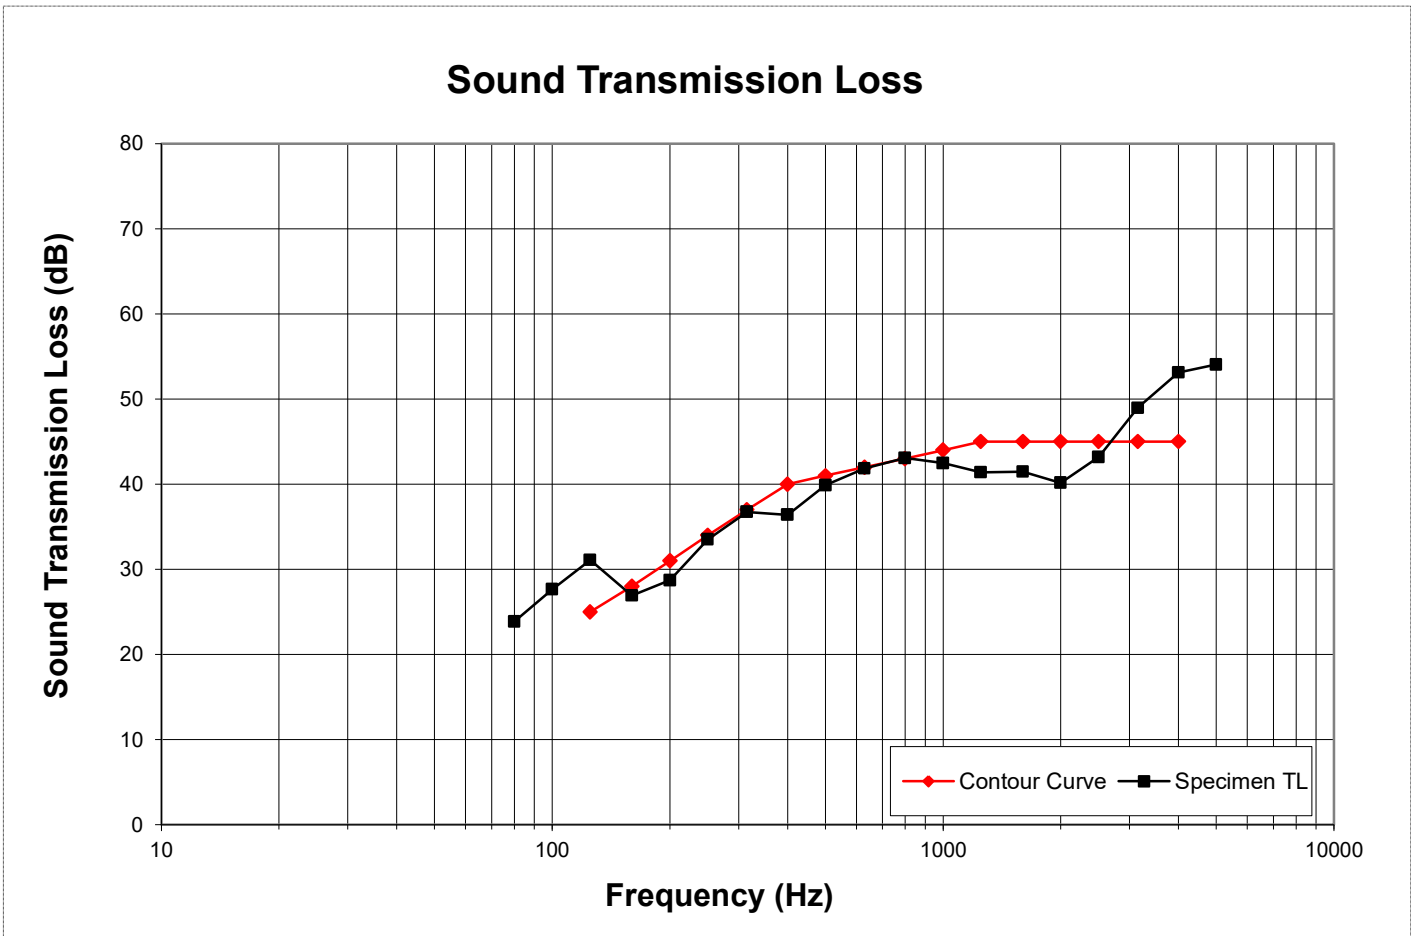
<b>Test Date</b>	01/15/13		
<b>ATI No.</b>	C4711.01C		
<b>Client</b>	WindLoch LLC		
<b>Specimen</b>	Series/Model: WS 75, tilt-turn window with 1-1/2" IG (1/2" laminated exterior, 3/4" air space, 1/4" heat strengthened interior), Glass temperature 75°F		
<b>Operator</b>	Daniel P. Platts		
<b>Sample Area</b>	1.79 m <sup>2</sup>		
<b>Filler Area</b>	11.20 m <sup>2</sup>		
	Source	Receive	Sample
<b>Temp C</b>	23	22	22
<b>RH %</b>	49	49	49

Note: To obtain the Sound Transmission Class (STC), read the Sound Transmission Loss of the contour curve at 500 Hz. The sum of the deficiencies below the contour curve cannot exceed 32. The maximum deficiencies at any one frequency cannot exceed 8.

<b>Test Date</b>	01/15/13		
<b>ATI No.</b>	C4711.01C		
<b>Client</b>	WindLoch LLC		
<b>Specimen</b>	Series/Model: WS 75, tilt-turn window with 1-1/2" IG (1/2" laminated exterior, 3/4" air space, 1/4" heat strengthened interior), Glass temperature 75°F		
<b>Operator</b>	Daniel P. Platts		
<b>Sample Area</b>	1.79 m <sup>2</sup>		
<b>Filler Area</b>	11.20 m <sup>2</sup>		
	Source	Receive	Specimen
<b>Temp C</b>	23	22	22
<b>RH %</b>	49	49	49

Freq (Hz)	Bkgrd SPL (dB)	Absorp (m <sup>2</sup> )	Source SPL (dB)	Receive SPL (dB)	Filler TL (dB)	Specimen TL (dB)	95% Conf Limit	No. of Deficiencies	Trans Coef Diff
80	36	5.1	94	67	36	24	1.8	-	5.0
100	37	5.6	100	68	40	28	3.0	-	5.7
125	36	5.4	105	70	48	31	2.3	0	9.6
160	38	4.7	106	75	47	27	2.9	1	12.8
200	37	5.6	111	78	51	29	0.7	2	14.1
250	34	5.3	110	72	56	34	0.9	0	14.2
315	30	5.8	107	66	59	37	0.7	0	14.1
400	28	5.7	107	66	64	36	0.7	4	19.8
500	26	6.0	108	63	68	40	0.6	1	20.4
630	24	5.5	111	64	72	42	0.8	0	22.5
800	23	5.9	111	62	78	43	0.1	0	27.1
1000	18	6.3	110	62	83	42	0.4	2	32.3
1250	17	6.7	111	64	86	41	0.5	4	36.5
1600	12	7.1	117	69	89	41	0.5	4	39.2
2000	8	7.4	107	61	88	40	0.3	5	39.9
2500	7	8.4	104	54	86	43	0.2	2	35.1
3150	6	9.8	105	49	88	49	0.3	0	30.7
4000	7	11.6	103	42	88	53	0.5	0	26.7
5000	6	14.4	100	37	87	54	0.5	-	24.9

**STC Rating**      **41**      *(Sound Transmission Class)*  
**Deficiencies**    **25**      *(Number of deficiencies versus contour curve)*  
**OITC Rating**    **35**      *(Outdoor Indoor Transmission Class)*

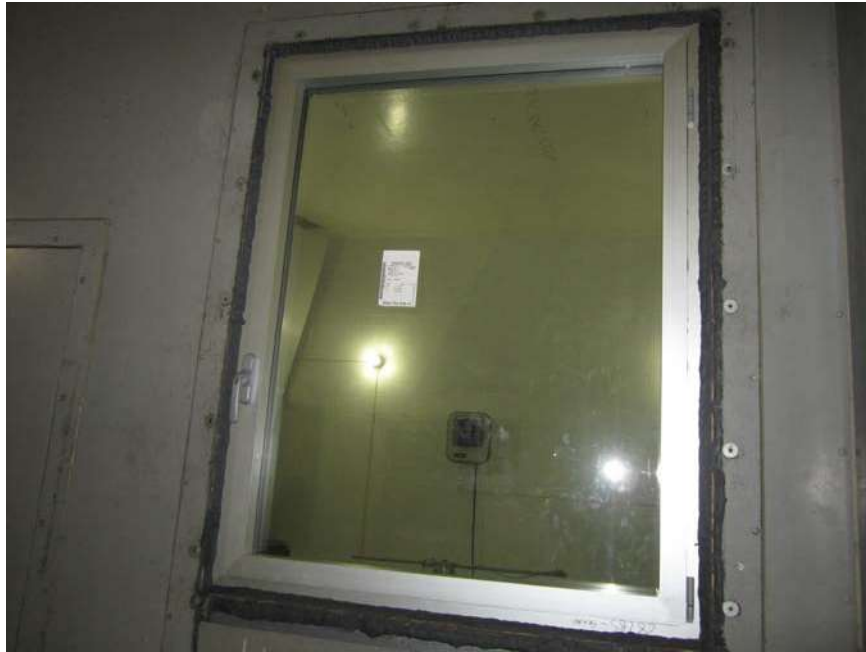
**Receive Room View of Installed Specimen**

A filler wall reducing element was used to reduce the test opening size. The reducing element consisted of two separate 2x6 wood frames filled with concrete to reduce the test opening size to accommodate the test specimen. A dense neoprene gasket was placed between the two wood and concrete frames. The window was placed on an isolation pad in the new test opening. Duct seal was used to seal the perimeter of the window to the test opening on both sides. The interior side of the window frame, when installed, was approximately 1/4" from being flush with the receiving room side of the filler wall. A stethoscope was used to check for any abnormal air leaks around the test specimen prior to testing. The vent was opened and closed at least five times prior to testing.

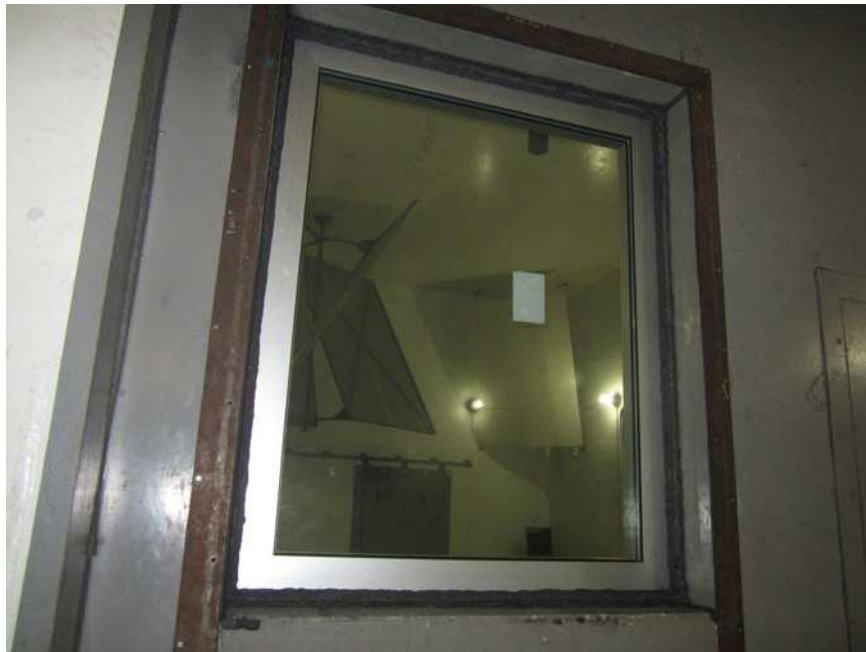
**Source Room View of Installed Specimen**
